Göbekli Tepe, an early Neolithic wonder in Turkey

Recent finds from excavation season 2012/2013

Deterioration of the “Quinta Nova Torres Vedras” wall tile panel – an analytical approach

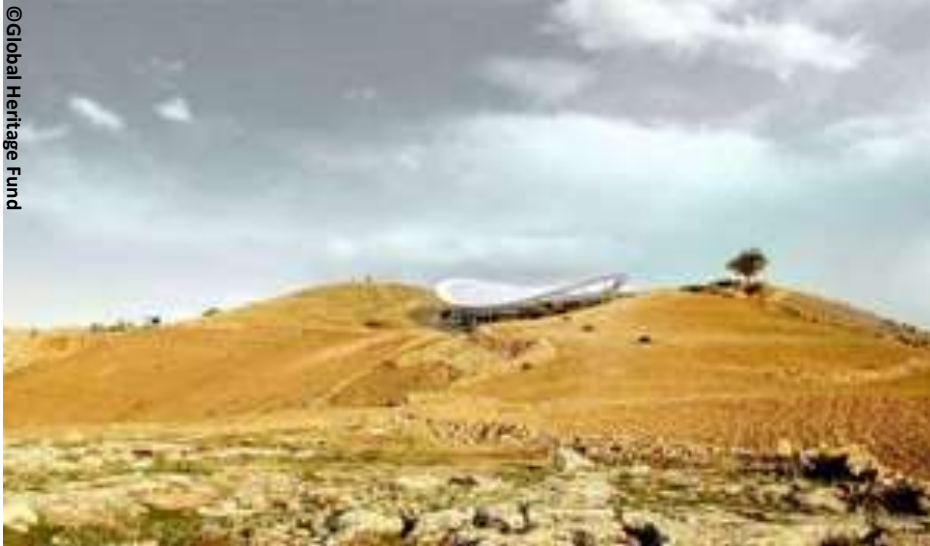
Canopy planned at the main excavation site at Gobekli Tepe

In 2010, the architectural committee working for the site (DAI) decided to erect a shelter designed by the architects Koblitz-Kleyer and Freivogel from Berlin. As the necessary planning and building process was expected to take several years, it was also decided that a temporary shelter should be installed comprising a wooden superstructure supporting a wooden roof covered with roofing felt. The upper (external) surface of the roofing felt was reinforced by a layer of green sand and to make it completely waterproof. Finally, a V-shape gutter was installed to ensure sufficient drainage. As the architectural structures exposed in the southern areas are extremely unstable and fragile it was decided that construction work should only be undertaken by the trained and experienced workmen from the excavation. These workmen are accustomed to moving around the prehistoric

Fire resistant paint will be applied to the wooden parts of the shelter in spring 2014. The final shelter will be a steel construction; the membrane itself will be fire resistant. After the erection of the permanent shelter the wooden temporary structure will be removed completely.

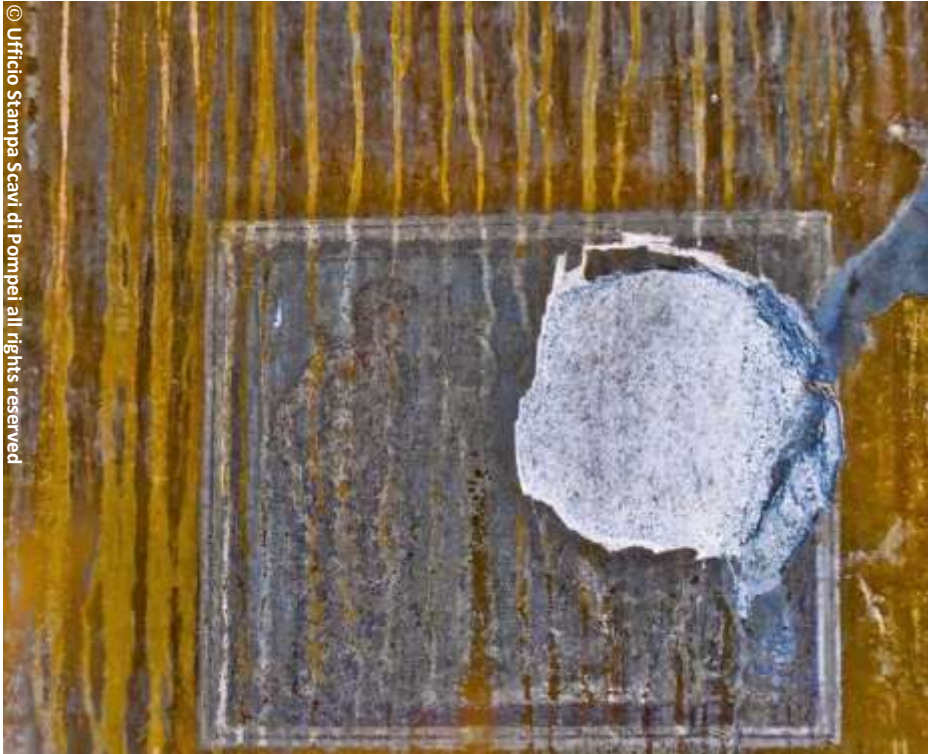
The portion of the image that was recently stolen from the House of Neptune, Pompeii

Police have launched an investigation into the theft of the 20-centimetre (eight-inch) wide fragment, which left a large damaged area in the fresco.

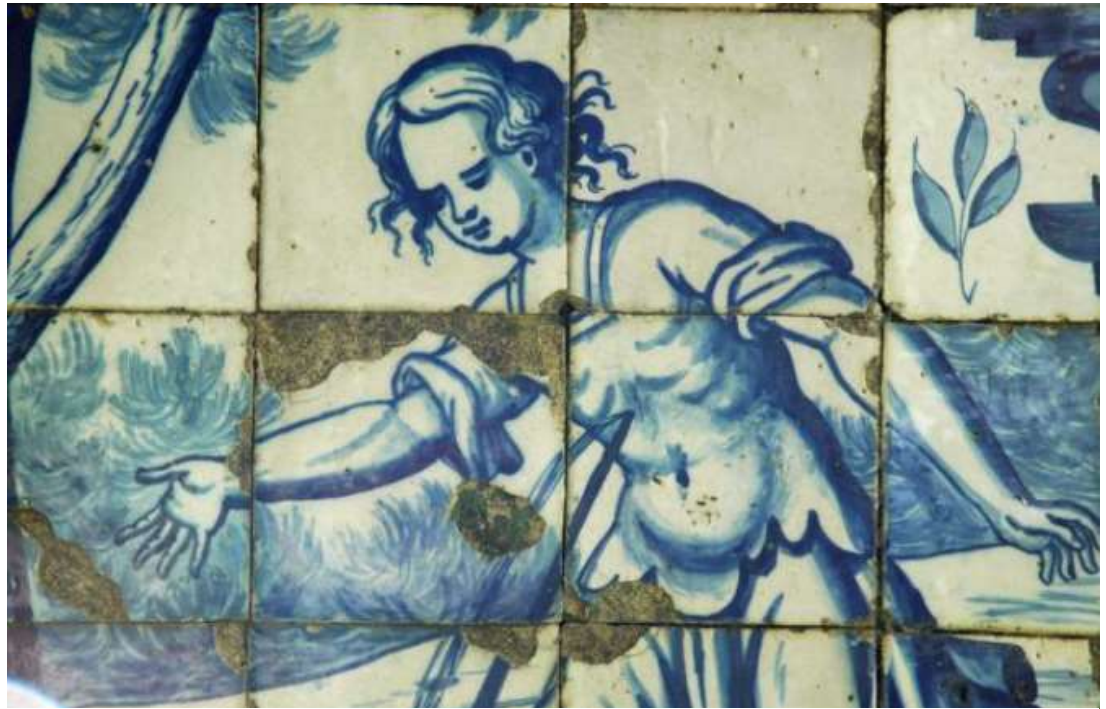
Loss of glaze and evidence of biological colonisation

Glaze spalling is present at the edges of the tiles exhibiting partial glaze loss. The development of micro-organisms is also associated with pores and loss of glaze.

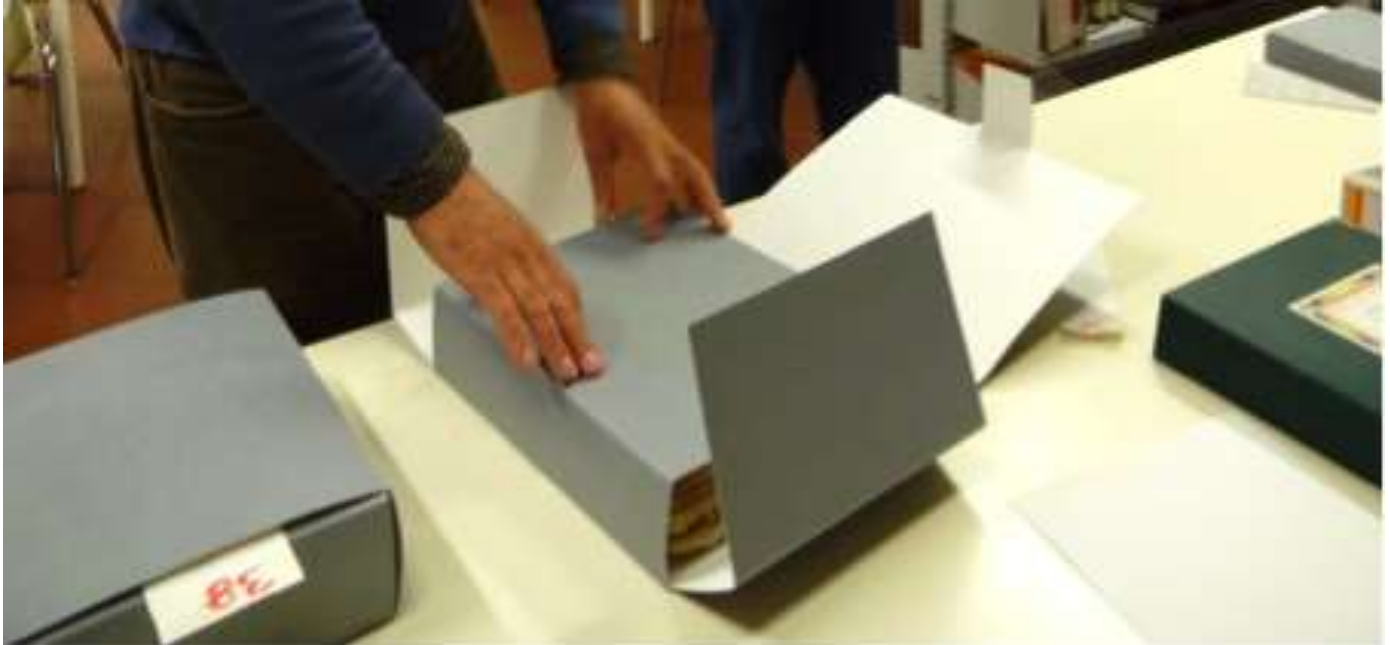
Housing an original manuscript in a four-flap folder (phase box)

After the assessment different kind of protective enclosures for library and archive material were created by the students, some to be kept with their own facsimiles and other, prepared with archival material, to be used for the housing of the original manuscripts previously analysed.
